# **Evaluation of FloodWalls™ Flood Fighting Barrier<sup>1</sup>**

Donald L. Ward and Perry A. Taylor

January 2007

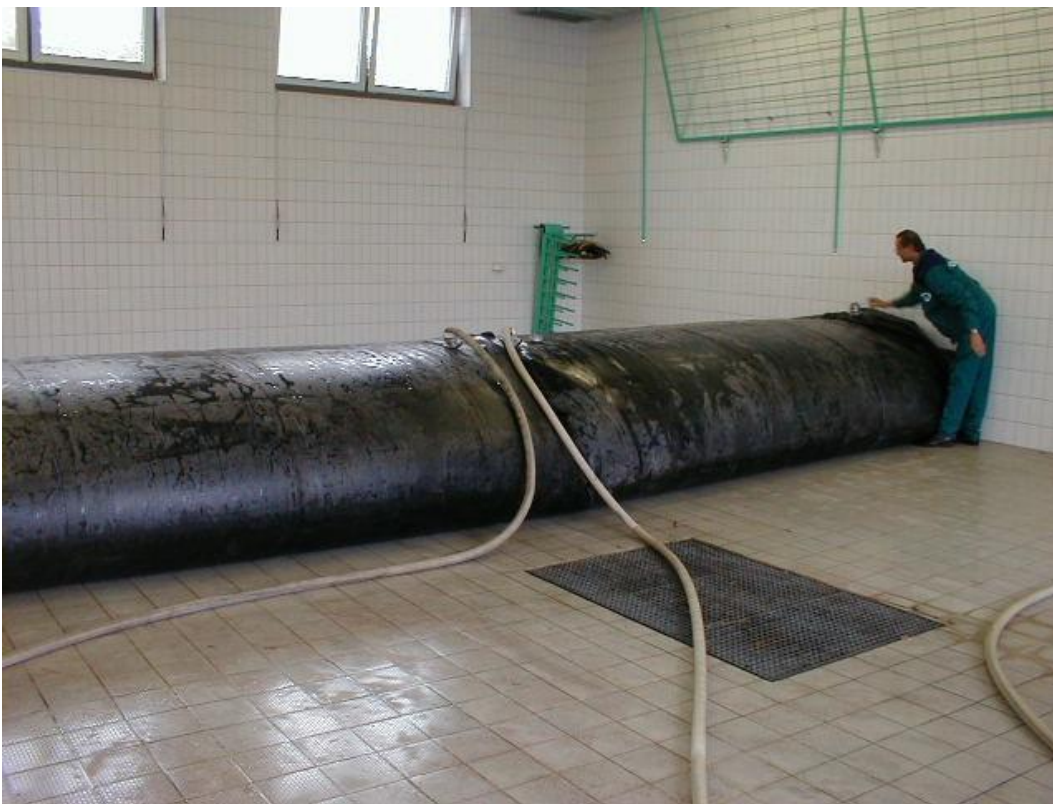
Figure 2. FloodWalls™ flood fighting units (from [www.floodwalls.com](http://www.floodwalls.com))

The Floodwalls™ units are large quasi-cylindrical bags made of a heavy-duty rubberized fabric (Figure 2). The units are manufactured in the Czech Republic by Rubrena Corp. and available in the US through FloodWalls, Inc.

A common problem with cylindrical water-inflated bags is that increasing water pressure from rising water on the pool side of the bags will cause the bags to roll away from the pool. To counter this effect, the FloodWalls™ units are constructed with two internal baffles that run the length of the units in the shape of an inverted "V." The baffles effectively prevent the units from rolling when flooded on one side.

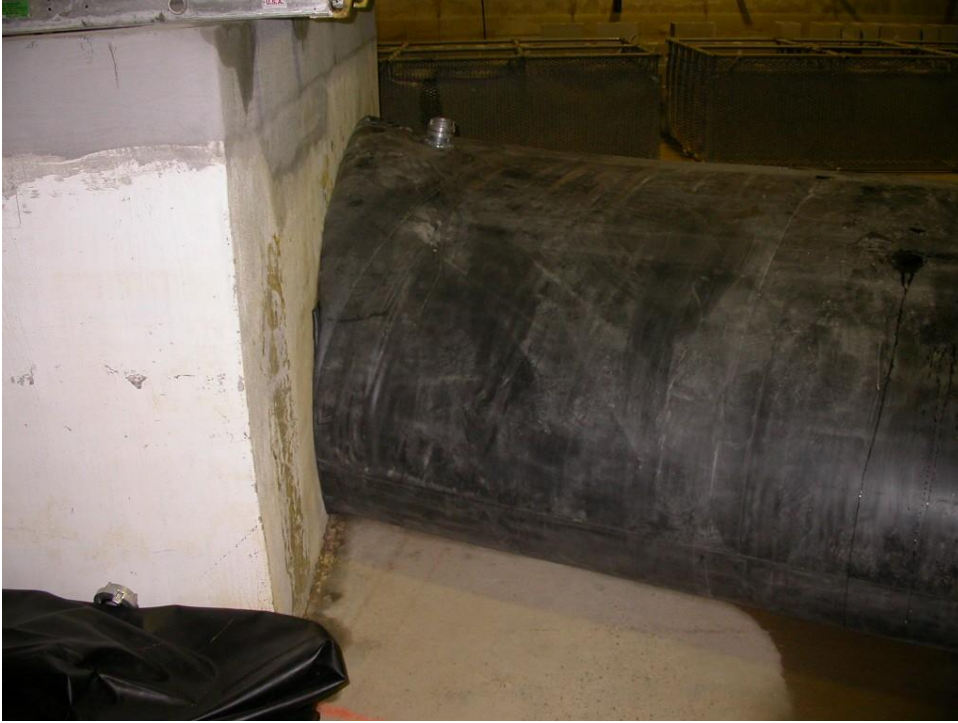
Figure 4. Unit A abutting the wingwall and showing one of the upper fill ports

The units received for testing were identified as Type A units. Each bag was constructed with four ports for filling and emptying, two near the top of the bag and two near the bottom. Each port was fitted with a European quarter-turn quick-connect fitting, but other fittings are available. An adapter was provided to attach the quick-connect fitting to the end of a 1-1/2-in-diam water line.

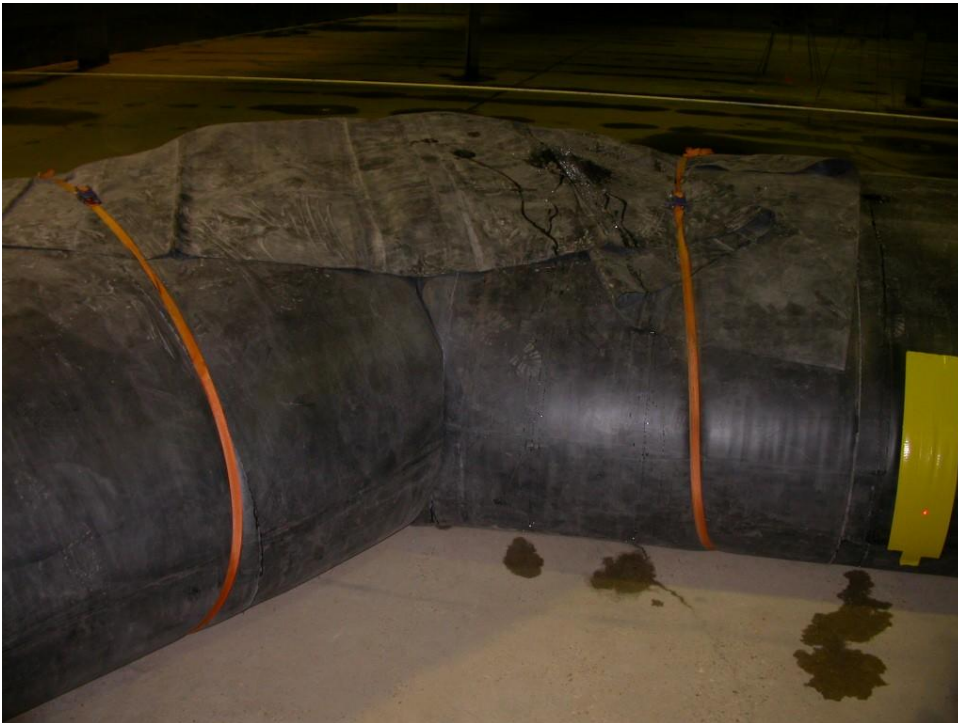
Figure 5. Corner at Units B and C

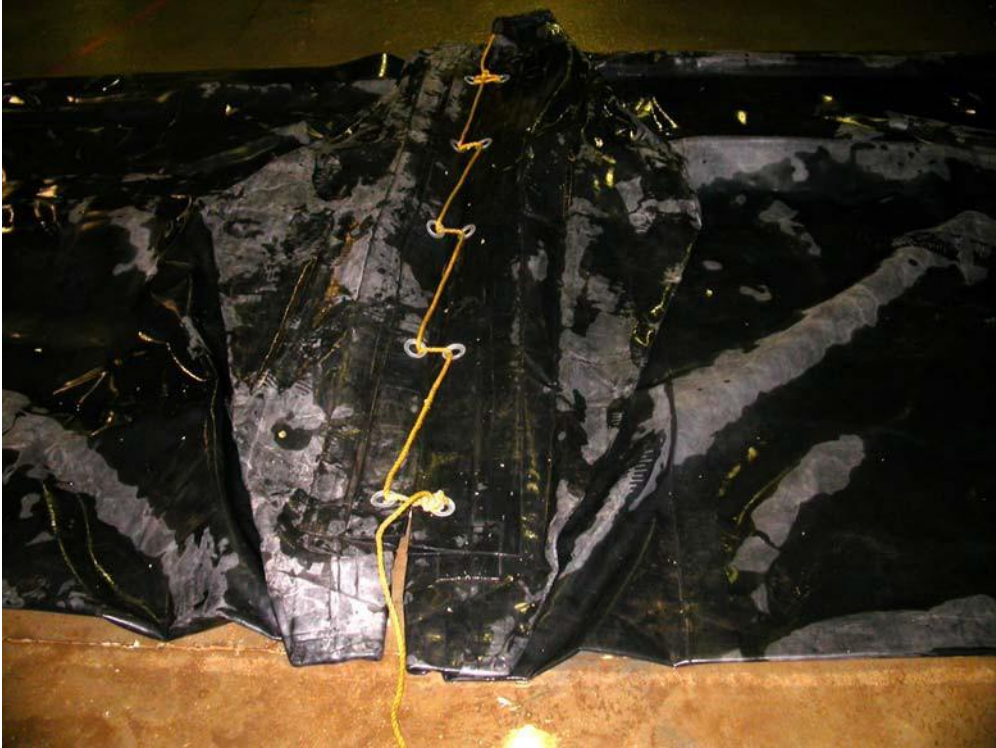
Figure 8. Two units tied together at their ends

Flaps at the ends of the units have grommet-reinforced holes that can be used to tie adjacent units together before filling as a protection against movement of the units.

Unlike the previous the construction, the units for this test were tied together at the ends. Figure 76 shows the ends of two units tied together.

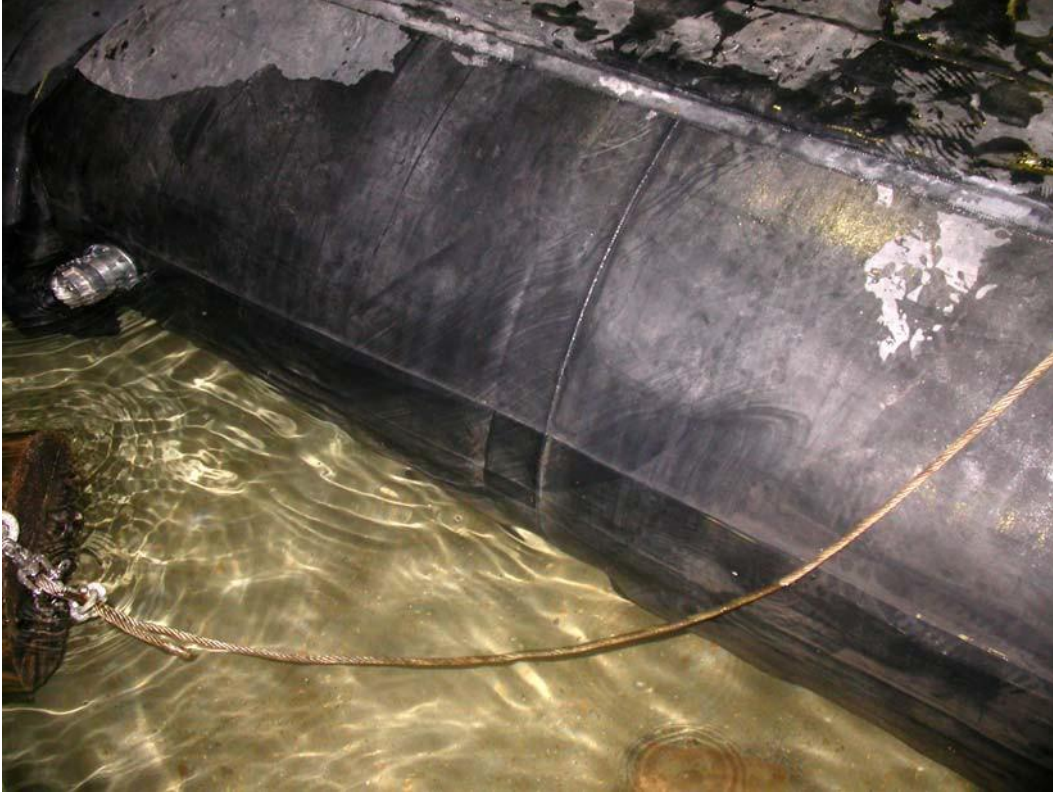
Figure 9. Twelve in log and location of impact on Unit B-2

Both logs struck near the center of Unit B-2. The 12 in log left barely perceptible scratches on the fabric but caused no damage. Scratches left by the larger log were more noticeable, but again caused no damage. Figure 78 shows the 12 in log and impact location on Unit B-2.

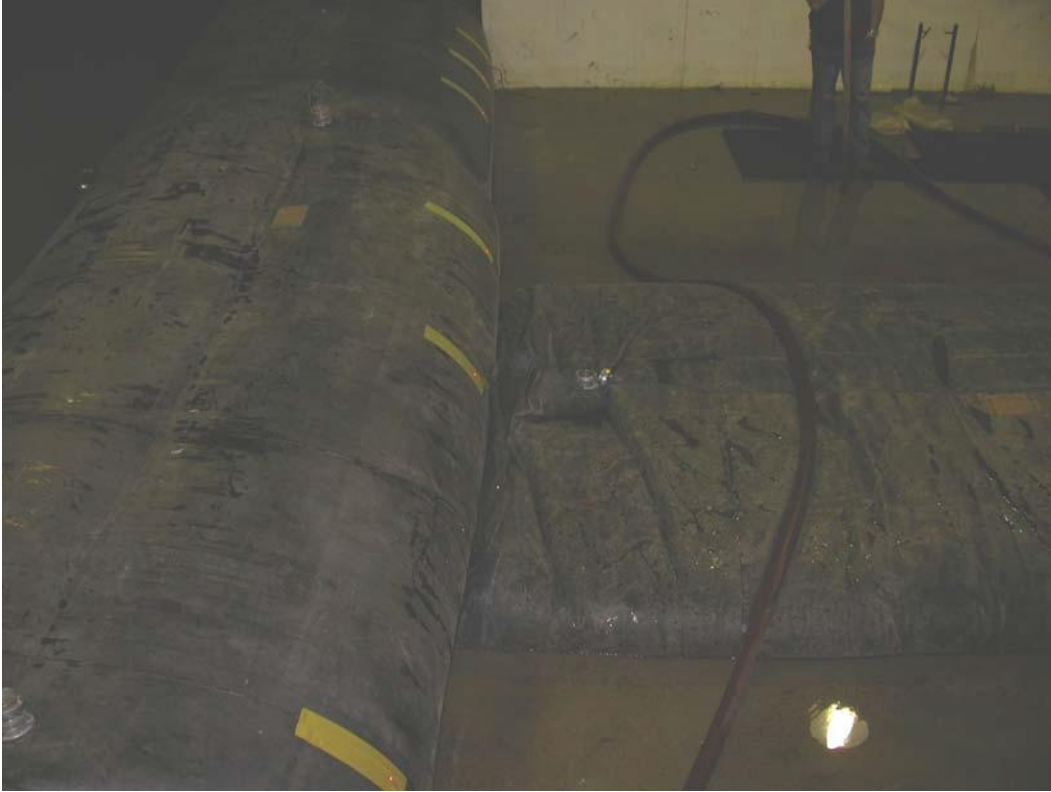
“T-

wall.” Unit E-2 was not tied to the other units and was installed strictly as a freestanding unit to provide support to the front row of units.

Although the testing protocol was completed, two additional tests were conducted to demonstrate the capabilities of the FloodWalls™ Barrier: a test with large waves and an overtopping test. For these additional tests an extra unit (E-2) was added to the units in Setup 2 as shown in Figures 87 and 88 to form a

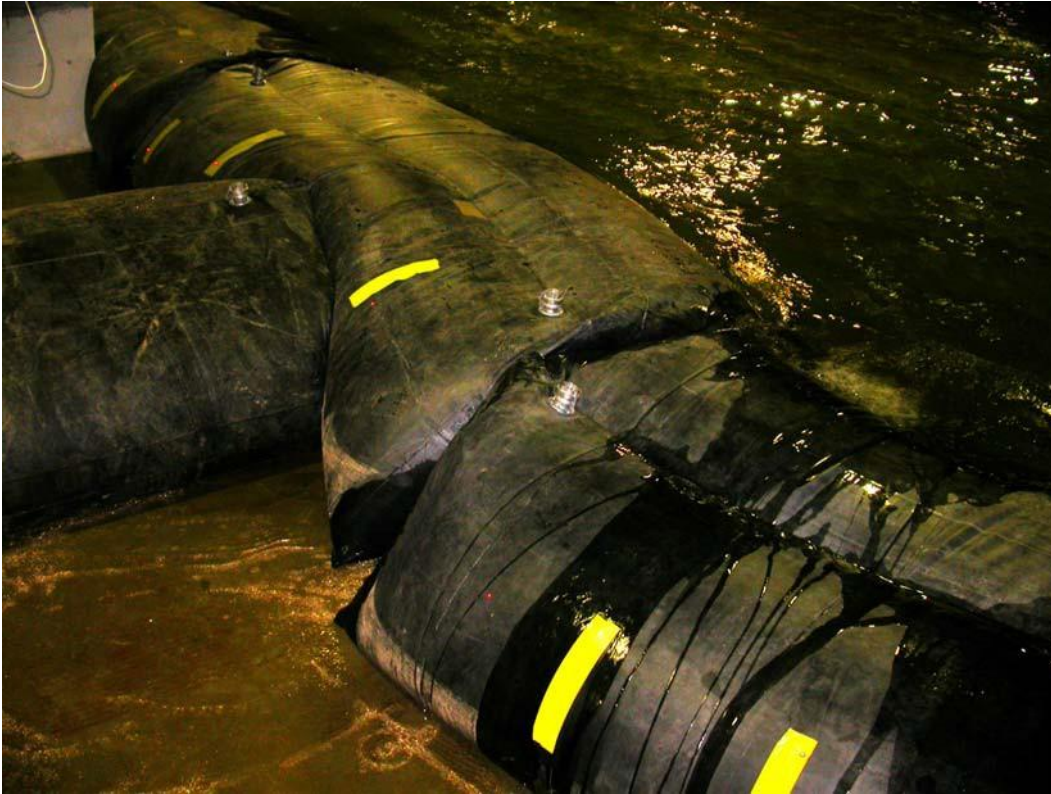
Because of the movement of Unit C during the large wave, high water test in the standard testing protocol, the decision was made to run the large waves again with the units arranged in the T-wall (Figure 87). The 10- to 12-in waves were again run for one 10-min run. Water depth for this test was 26.67 in.

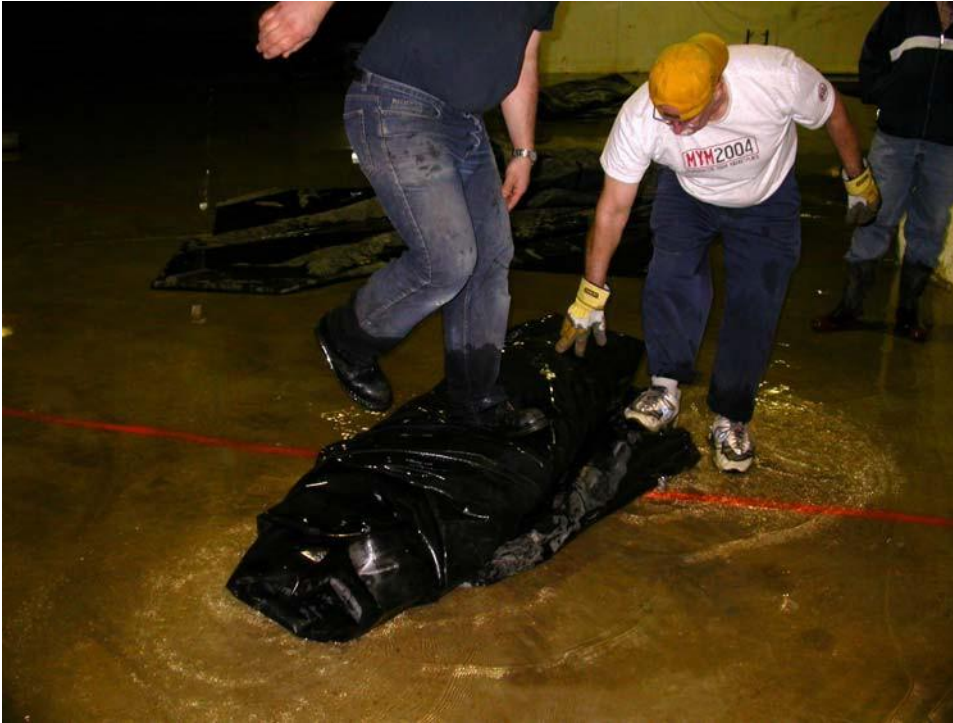
After opening the drain valves (Figure 109), it took 30 min for the units to empty. The bags were then folded and rolled to force additional water from them (Figure 110), then unrolled and unfolded, and refolded and rolled (Figure 111) for storage.

A small forklift (Prime Mover L1200) with driver was used to load the units into the shipping crates. A total of 8 units were packed, including 3 units that were not used in this test series. As the units were being packed, it was decided to hang a unit vertically from the Prime Mover to try and further drain the unit and reduce the weight for shipping (Figures 112 and 113). Using the Prime Mover to further drain the units worked well, and six of the units were unrolled, hung by the Prime Mover, and then re-rolled and crated.

Total time to drain and prepare units for packing was 1 hr 43 min for two people, or 3.43 man-hrs. The test was considered complete at this time. An additional 1 hr 20 min for three people (including the Prime Mover operator) was used to unroll, drain with the Prime Mover, re-roll, and pack in crates (Figure 114) but is not considered part of the disassembly time. No equipment was used during the disassembly; one Prime Mover L1200 forklift was used during additional draining and crating.
